INTRODUCTION

This information sheet deals with the care and conservation of metals used in building, including cast and wrought iron as fencing and decorative panels, steel-framed windows and roof plumbing. For further information refer to the references at the end of the sheet, and to the separate information sheets on Corrugated Roofing, and Slating, Tiling and Roof Plumbing.

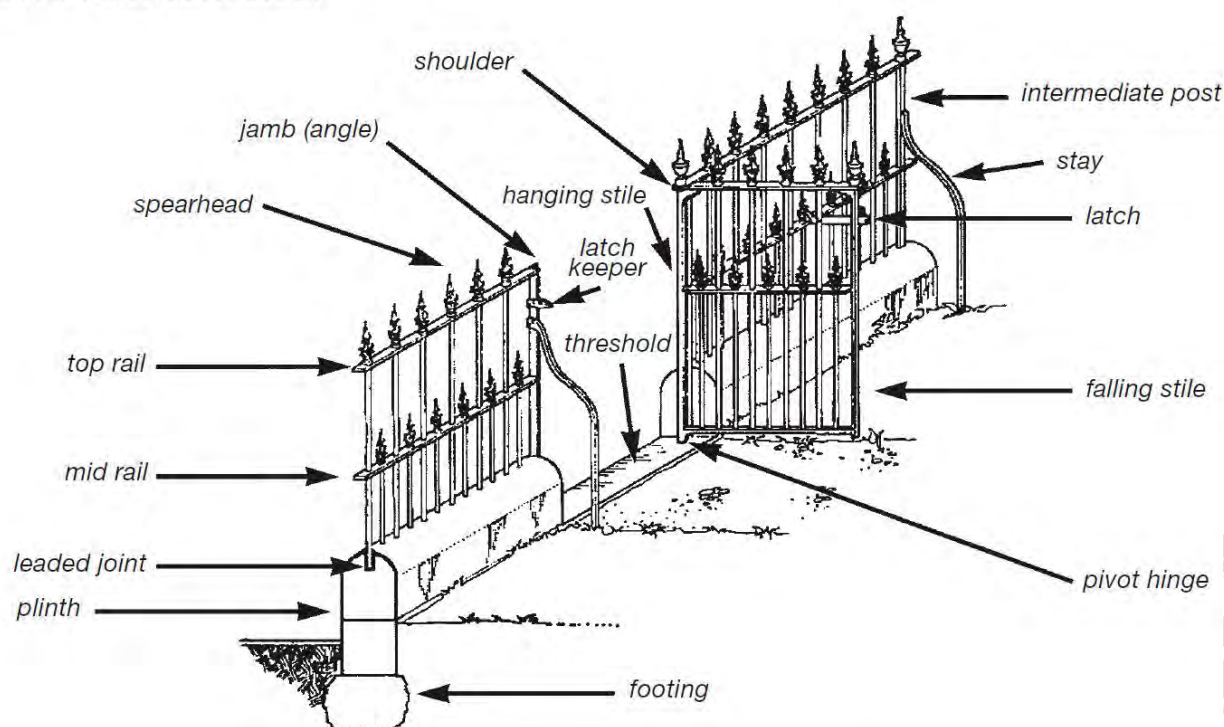
Iron Palisade Fence Construction

Palisade fences typically have a low stone or rendered brick plinth surmounted by a palisade of wrought iron or mild steel shafts. The shafts penetrate flat wrought iron or mild steel rails and carry ornamental spearheads or tops of cast iron. The iron palisade is supported along its length by posts of cast or wrought iron or masonry.

Illustration from Ian Stapleton, *How to Restore the Old Aussie House*, Flannel Flower Press, 1991

A common conservation measure needed for palisade fences is to replace stays that may have been misguidedly removed to allow easier access for lawnmowers and the like. The stays are needed to brace the fence and ensure its lateral stability.

Crevice corrosion can occur where the shafts penetrate the rails, and also between the spearheads and the top rail. Careful filling and painting of these areas is required to eliminate crevices where corrosion may occur.

The traditional practice was to set the iron shafts in a leaded joint by pouring molten lead into an oversize hole around the base of the shaft and tamping it down as it cooled. The lead insulates the iron from damp stone and, because it is soft, allows a certain amount of movement due to thermal expansion and contraction of the iron.
